Geotechnical Investigation Report

Riverbend Development, Mirani

Project Number: 304570195

REPORT ON GEOTECHNICAL INVESTIGATION – RIVERBEND DEVELOPMENT, MIRANI QLD

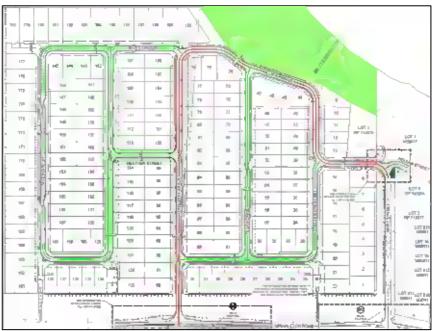
Figure 1-1 Riverbend Development Proposed Roadworks Plan¹.

Stantec Australia Pty Ltd were commissioned by Certainty Wealth to undertake a geotechnical investigation for the proposed pavements at Riverbend Development, Mirani (**Figure 1-1**, below). We understand the investigation was required to assess the subsurface conditions to help aid pavement design for the proposed residential subdivision. It should be noted that a contamination investigation, acid sulfate soils assessment and slope stability analysis did not form part of this investigation. The aim of this report is to provide an overview of the geotechnical conditions encountered at each investigation location.

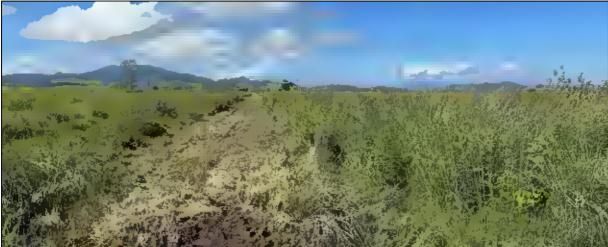
Figure 3-1 Select Site Photographs at the Time of the Field Investigation.

The proposed land development site is located in Mirani along Mirani Eton Road and is characterised by a mixed-use landscape comprising residential buildings and agricultural land. The site is bordered by densely vegetated cane fields, cattle-grazing paddocks, and the Pioneer River, which runs adjacent to the northwestern boundary. The area features a combination of low-density vegetation and mature trees reaching heights of approximately 10 to 20 meters. The northwestern portion of the site is defined by a two terraced slope that transitions into the Pioneer River. At the time of the field investigation, recent high levels of rainfall had occurred at the site causing ground conditions to be wet and boggy.

A site figure is provided in **Appendix A** at the end of this report which shows the extent of the site and test locations. Select photographs showing the general site conditions at the time of investigation are shown in **Figure 3-1**, below, with full site photographs shown in **Appendix D**.

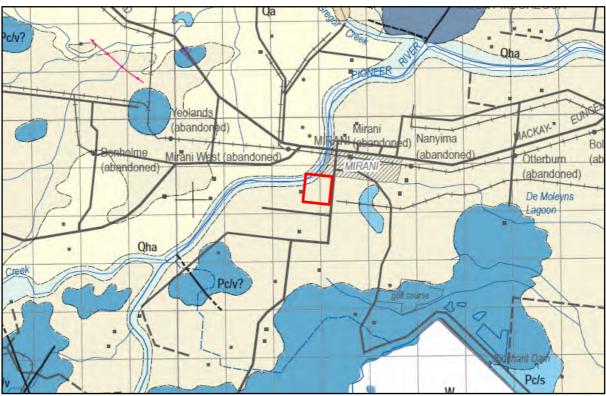
Figure 3-2 Mirani Local Geology (Site Marked as Red Square).

Based on the published compiled geological map of the area by QLD Department of Natural Resources, Mines and Energy (2014)², the site is likely to comprise of clay, silt, sand and clayey to sandy gravel; alluvial fans, sheetwash and floodout sheets. The underlying rock is likely to comprise of the Early Permian Carmila beds unit. Material encountered on site was generally in agreeance with the mapped lithology shown in **Figure 3-2**, below.

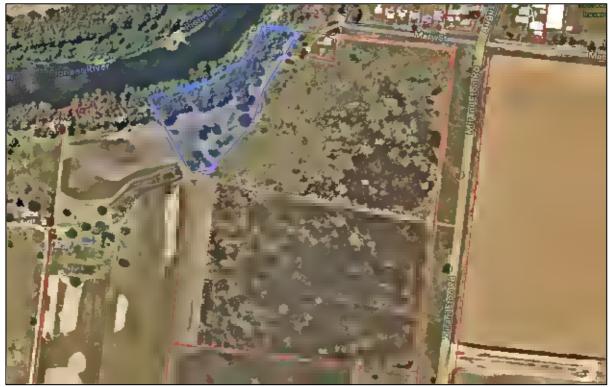
Figure 6-1 Riverbend Development Slope Location (Marked as Blue Box)⁴.

The proposed development footprint is generally flat or gently sloping. During the investigation, we undertook an inspection on the slope situated on the northwest portion of the property (**Figure 6-1**, below). Photographs captured at the time of the inspection can be seen in **Appendix D**. The northwest portion of the site is boarded by the Pioneer River and consists of approximately two terraces (potentially sloping more than 15%). The lower terrace was densely vegetated with mature aged trees and minimal grass cover. The upper terrace consisted of sparse tree cover and densely vegetated grasses. Several washouts were noted within the sloped area. We understand there is no development planned for this area. Should development be proposed in this area, a full slope stability assessment will be required.

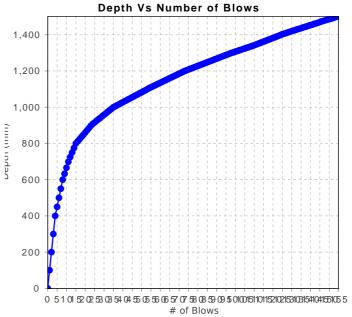
Insitu California	Insitu California Bearing Ratio - dynamic cone penetrometer (Q114B)										
Moisture Cond	ition		Moist to Wet								
Starting Refere	ence Point		0 (Surface)								
Layer	Layer Thickness (mm)	Depth (mm)	Equivalent California Bearing Ratio								
1	400	0 - 400	1.5								
2	200	400 - 600	3.5								
3	200	600 - 800	7								
4	200	800 - 1000	20								
5	500	1000 - 1500	> 60

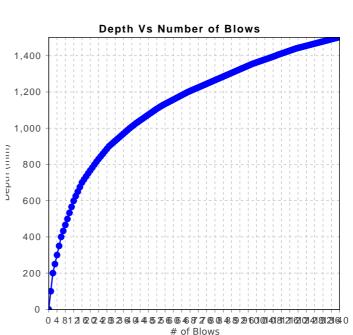
Remarks: Q114B DCPs Sample Location: TP02

Insitu California Bearing Ratio - dynamic cone penetrometer (Q114B)				
Moisture Condition		Moist to Wet		
Starting Reference Point		0 (Surface)		
Layer	Layer Thickness (mm)	Depth (mm)	Equivalent California Bearing Ratio	
1	200	0 - 200	1.5	
2	399	200 - 599	4.5	
3	301	599 - 900	11	
4	300	900 - 1200	30	
5	300	1200 - 1500	> 60

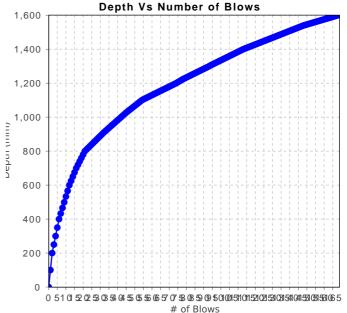
Sample Location: **TP03**

Insitu California Bearing Ratio - dynamic cone penetrometer (Q114B)				
Moisture Condition		Moist to Wet		
Starting Reference Point		0 (Surface)		
Layer	Layer Thickness (mm)	Depth (mm)	Equivalent California Bearing Ratio	
1	200	0 - 200	1.5	
2	400	200 - 600	4.5	
3	200	600 - 800	9	
4	299	800 - 1099	25	
5	501	1099 - 1600	60
